2005 6.0L DIT RUNNING CHANGES

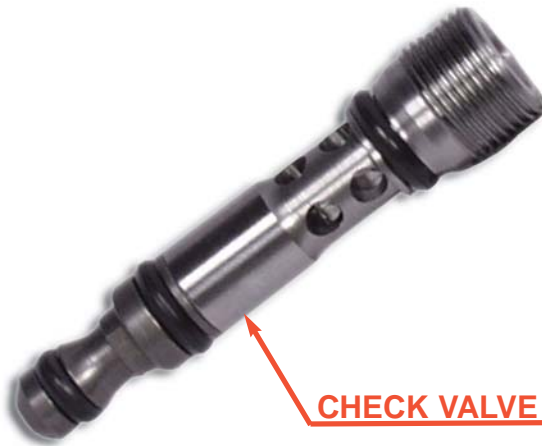
High-Pressure Stand Pipe

- The high-pressure check valve has been moved from an integral part of the stand pipe to the supply port plug.
- The change began with engine build date October 28, 2004 and engine serial number 6426234 on Indianapolis built engines and 0174191 on Huntsville built engines.

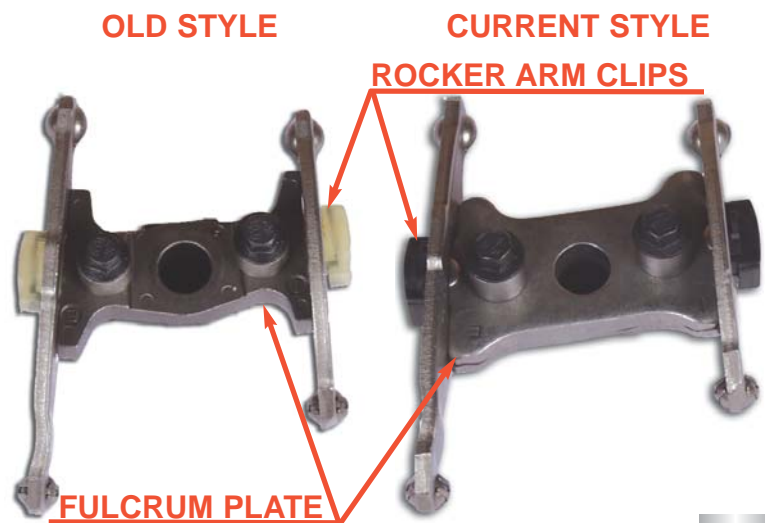
Rocker Arm Fulcrum Plate

- The rocker arm fulcrum plates have a new appearance due to a change in the manufacturing process.
- The plastic rocker arm clip has been made more robust by improving the plastic material.
- **NOTE: Service kits are available for the new fulcrum plates. The new design is reverse compatible with the previous design.**

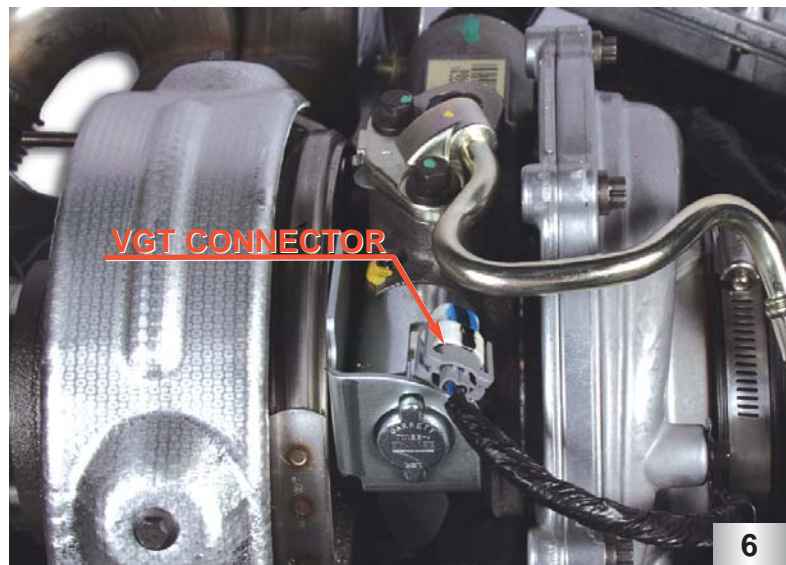
VGT Control Valve Connector

- The engine sensor harness has received several changes during the 2005 MY. Most of the changes have been made to reduce chafe points and provide more secure connections.
- One noticeable change is a new VGT control valve connector.
- The new connector will provide a more secure connection to the VGT control valve.
- **NOTE: The VGT control valve did not change.**

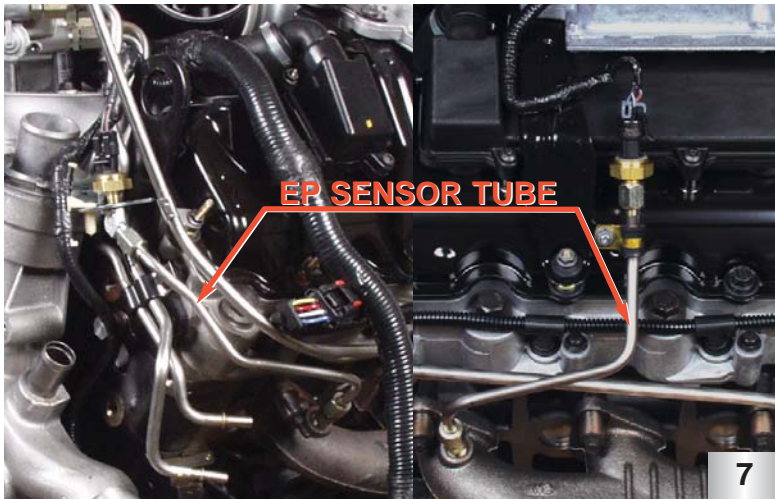
Exhaust Pressure Sensor Relocation

- The Exhaust Pressure (EP) sensor has been relocated to the FICM bracket.
- This change requires a new EP tube and FICM bracket to be used.
- The engine sensor harness had to be lengthened to accommodate the new sensor location.
- **NOTE: It is important to secure the nut on the EP sensor tube when removing the EP sensor.**

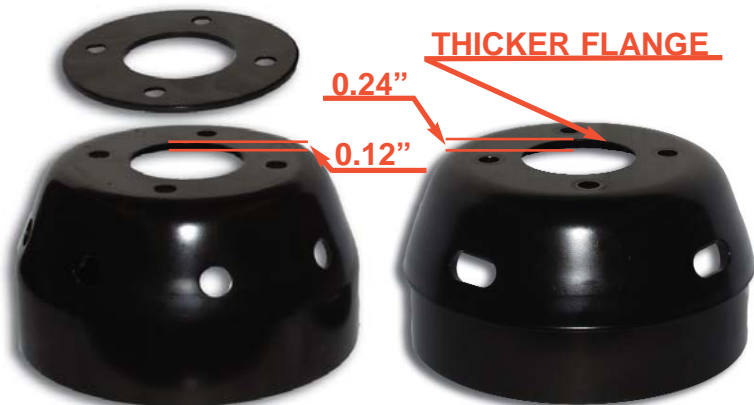
Water Pump Pulley

- The water pump pulley has been made more robust with the use of a thicker flange.
- The new water pump pulley design does not require the separate flange support plate as used on the previous design.

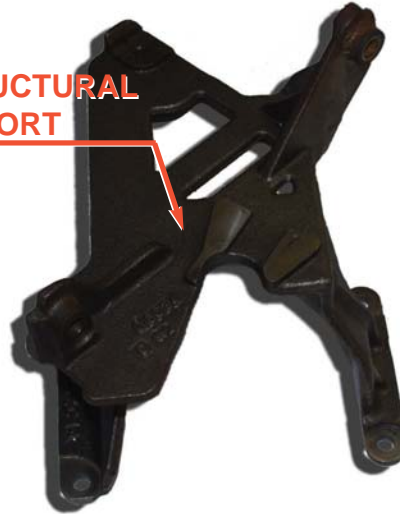
Previous Turbocharger Bracket

- The previous style turbocharger bracket has been improved to make the engine less sensitive to moan/droan concerns.
- This bracket went in production on September 29, 2003 beginning with engine serial number 6155637 for Indianapolis built engines and engine serial number 0094580 for Huntsville built engines.
- This bracket was used on 2004.25 and early 2005 MY engines.

LESS STRUCTURAL SUPPORT

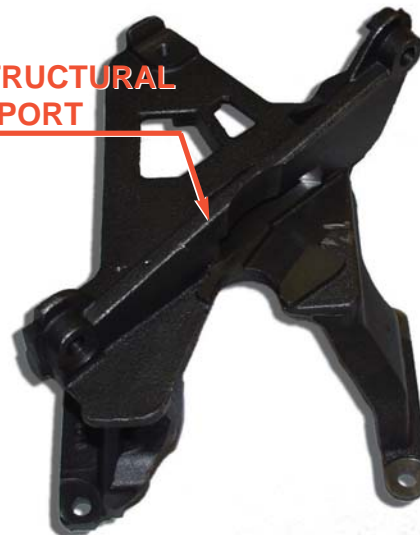
Current Turbocharger Bracket

- The current production turbocharger bracket has been made more robust by adding material across the center of the bracket.
- The new design minimizes the moan/droan concerns.
- The current bracket went into production on January 5, 2005 beginning with engine serial number 6470111 for Indianapolis built engines and engine serial number 0189356 for Huntsville built engines.
- **NOTE: The current bracket is reverse compatible with 2004.25 and early 2005 MY engines.**

ADDED STRUCTURAL SUPPORT

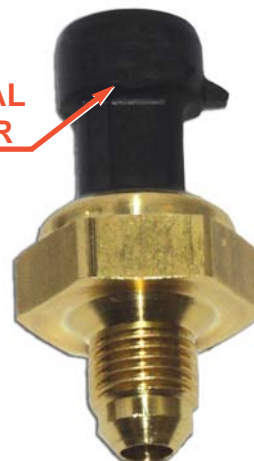
Optimized Exhaust Pressure Sensor

- A new Exhaust Pressure (EP) sensor went into production on January 14, 2005.
- The new sensor incorporates an improved ceramic sensing disc that is less susceptible to exhaust corrosion.
- The optimized sensor can be identified by the International part number 1850353C1 or 1850352C1 located near the top of the sensor body.
- **NOTE: The optimized EP sensor is available as a service part for 2003.25, 2004.25, and early 2005 MY engines which use different mounting threads.**

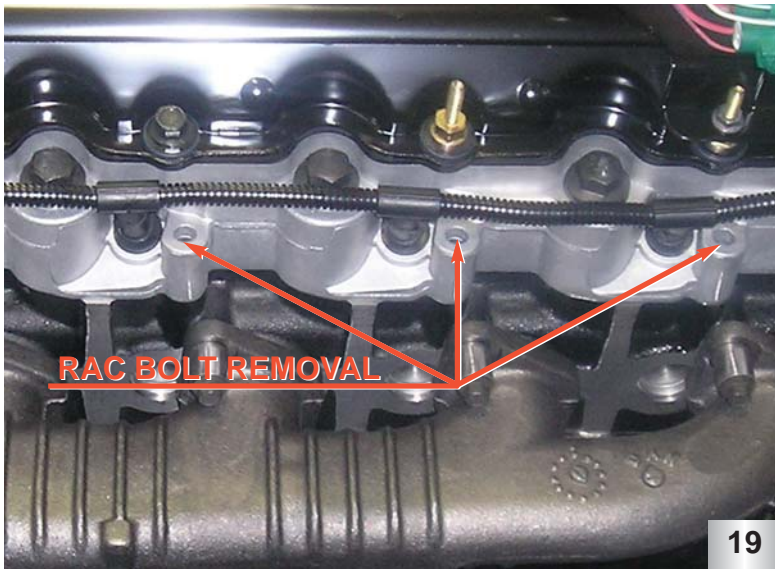
Rocker Arm Carrier (RAC) Bolts

- The cylinder head is now manufactured without the four outer rocker arm carrier (RAC) hold down bolt holes.
- The rocker arm carrier (RAC) still has the bolt holes in the casting with no bolts installed.
- The reason for the change is the clamp load provided by the cylinder head bolts is sufficient to for the rocker carrier.
- This change began with engine serial number 6537996 on April 5, 2005 on Indianapolis built engines.
