# Technician Turbocharger Guide for the Powerstroke Engine

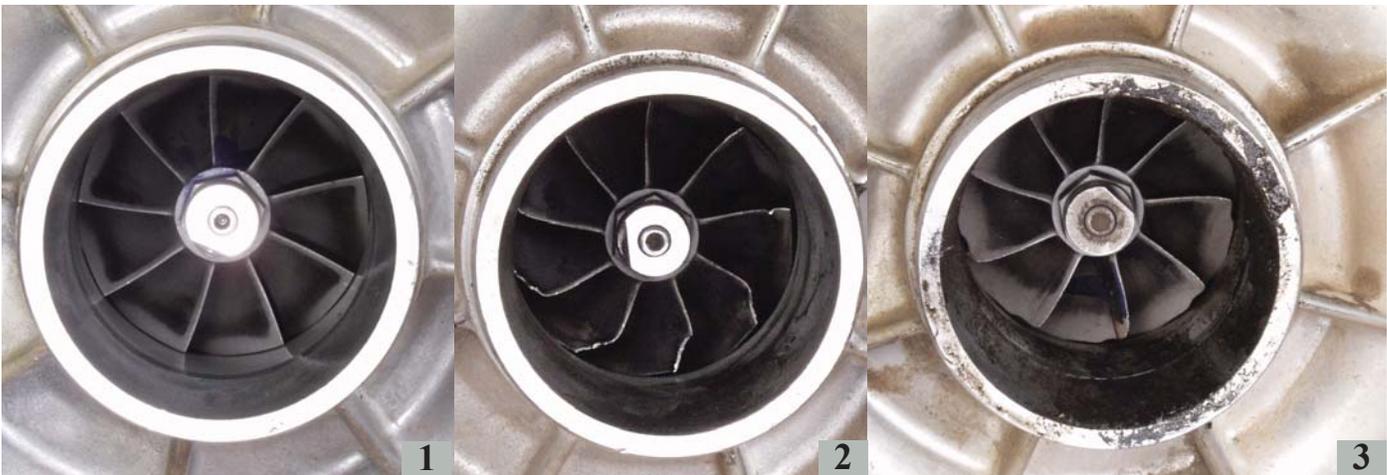
### Good Turbocharger:

Compressor blades are clean and straight. There are no large gaps between the compressor housing and the compressor wheel. No visible damage to blades. This turbocharger should not be replaced.

### Foreign Object Damage:

This compressor wheel shows signs of some outside object (nuts, bolts, screws, etc.) coming in contact with the blades while they were spinning.

### Dirt Ingestion:

Also called dusting. The compressor wheel blades show signs of erosion from dirt entering the intake air system. The blades are rounded off and there is dirt accumulation in the compressor inlet.

**Note:** If damage to the compressor wheel is found, the intake air system should be cleaned and inspected for foreign objects, poor maintenance, broken components, or improper installation.

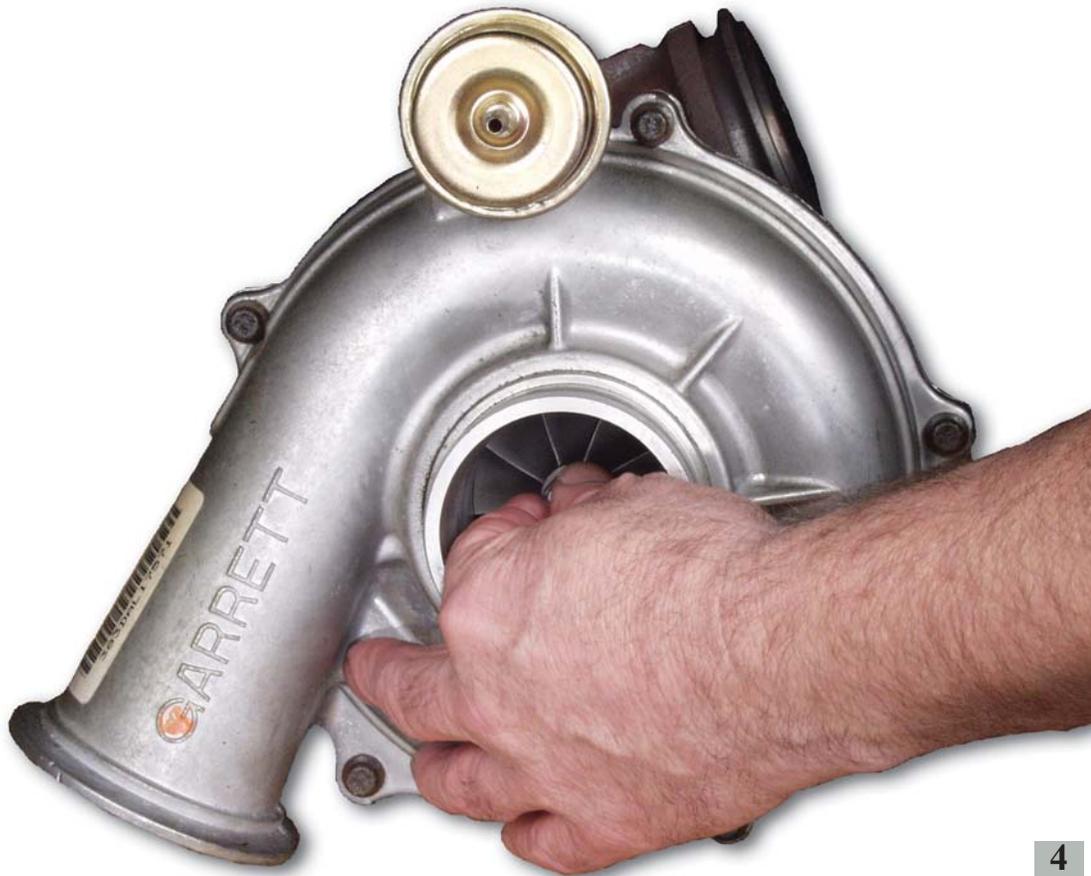
Does any evidence of wheel to housing contact exist, such as witness marks on the housing or rolled edges on the wheel? Before testing a service part replacement, pour some clean oil into the lube oil passages.

Spin the compressor wheel to make sure that it spins freely. The wheel should not contact the housing.

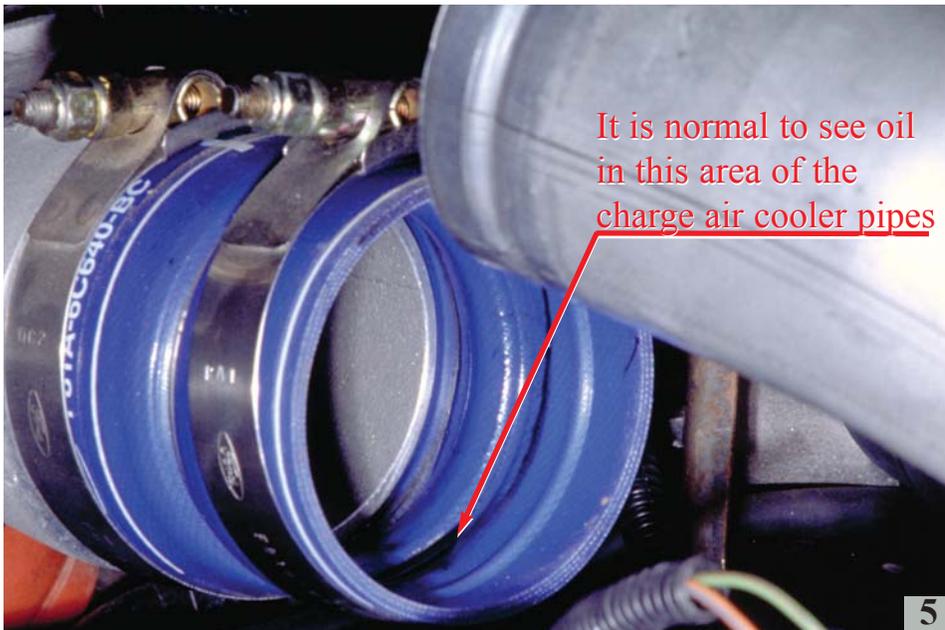
**Normal Oil Carryover:** The photo to the left shows normal oil carryover in the charge air cooler pipes. This condition can be aggravated by excessive air inlet restriction. The turbocharger should not be replaced for this condition.

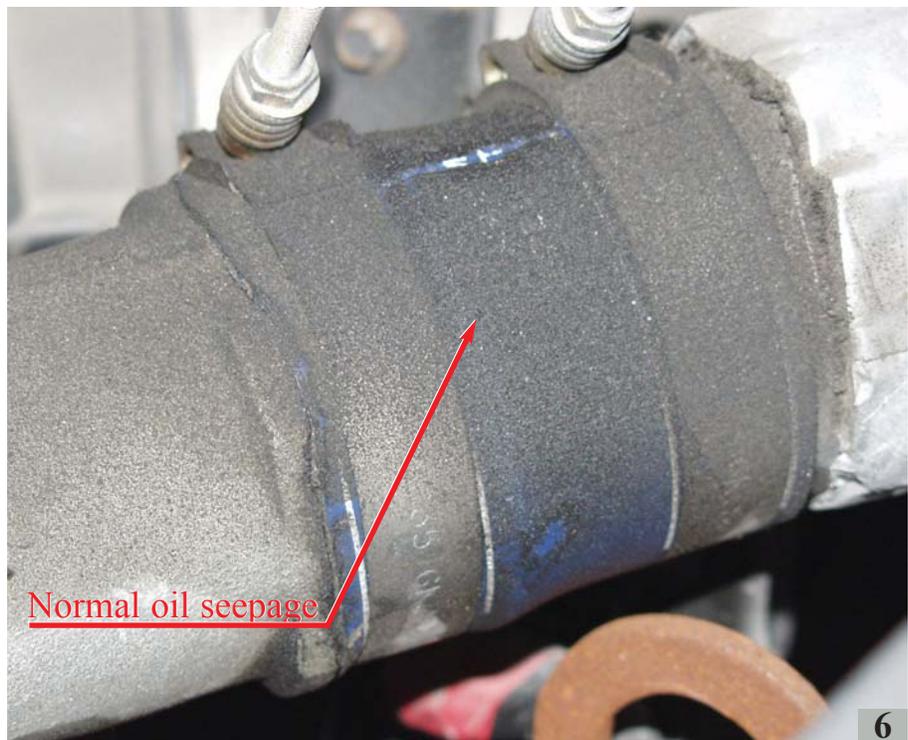
**Normal Oil Seepage:** The photo to the right shows normal oil seepage on the charge air cooler connections. This condition can be aggravated by excessive air inlet restriction or an overfilled crankcase oil level (refer to SSM 11982). The turbocharger should not be replaced for this condition.

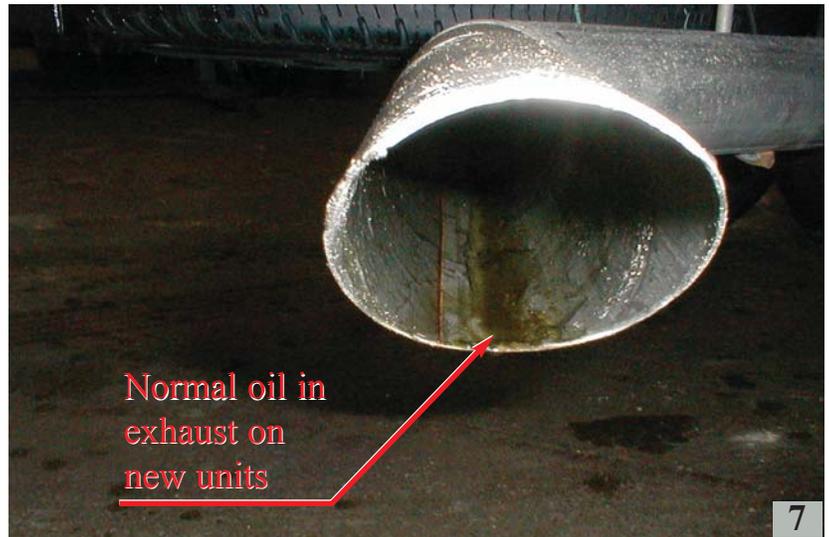
On very low mileage trucks, (typically less than 1000 miles) some turbochargers have been replaced because of an "oily residue" exiting the exhaust pipe. Be aware that during the manufacture of exhaust pipes, lubricants are used in the bending process and to prevent rust. Do not consider replacing the turbocharger just because oil is coming out of the tailpipe. The initial oil in the engine has had dye added, so inspect with a blacklight first. If it is thought that the oil is from the engine, loosen the exhaust pipe from the turbocharger outlet and look for signs of engine oil exiting the turbocharger. If the turbocharger is leaking oil into the exhaust, expect to find the bearings in the unit to be worn and for wheel rub to be present.

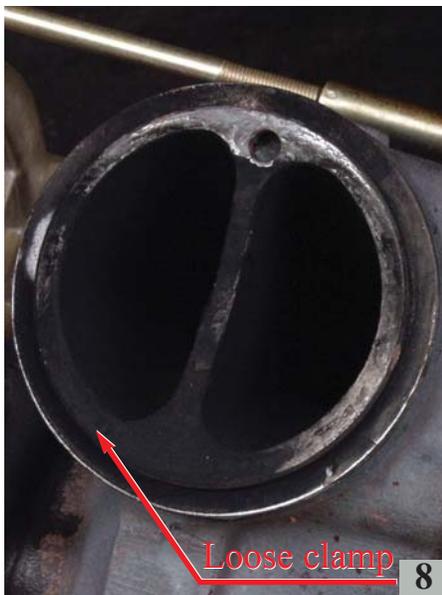
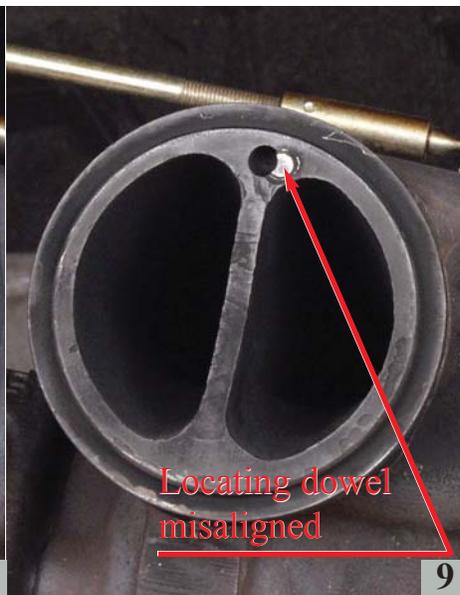
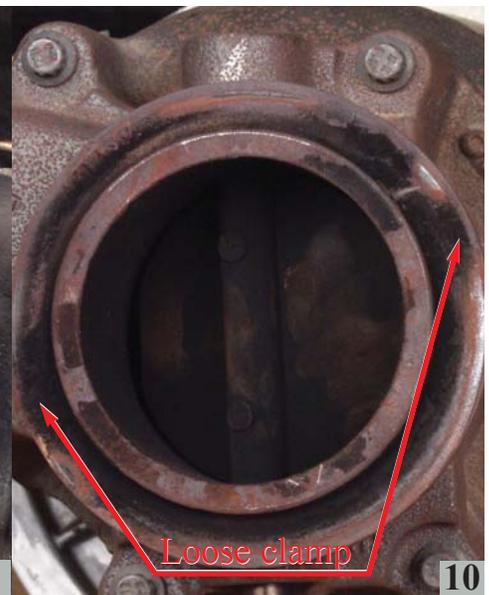
Turbochargers have been replaced for noise concerns when the concern is exhaust mis-alignment at the connections. Carefully inspect the exhaust connection at the inlet to the turbine housing, and the turbine exhaust outlet to exhaust pipe connection. Mis-alignment at these connections will often produce noise complaints. Re-aligning and tightening the V-band clamp can often repair the noise concern. If the turbocharger itself is responsible for excessive noise, expect to find wheel to housing rub, and bearing failure, as illustrated in photo 4.

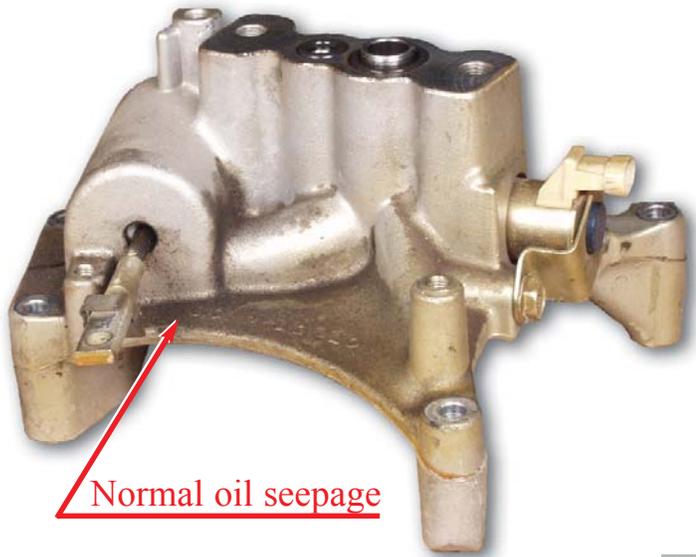
**Normal Oil Seepage:** It is normal to see some oil seepage past the seal on the EBP actuator rod. The photo to the left shows this normal seepage.

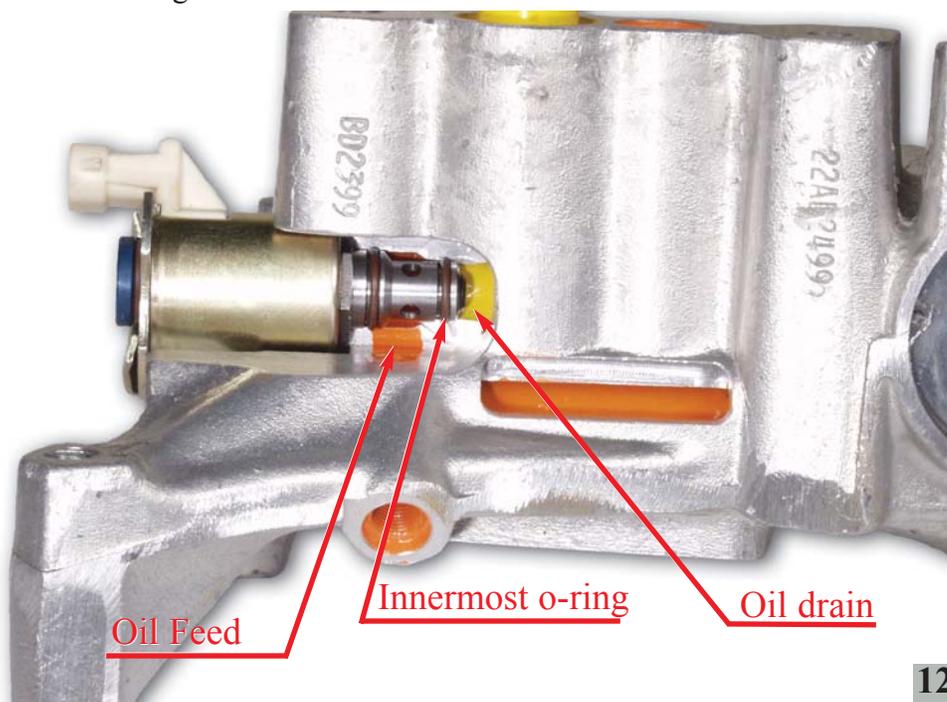
Turbochargers have been replaced when the exhaust backpressure system (EBP) malfunctions. If performance is low, disconnect the EBP actuator rod from the bell crank, and tie the valve open. If this resolves the performance concern, make sure the valve in the exhaust rotates freely. If it does, then suspect the regulator to be at fault. The exhaust backpressure regulator and the regulator o-rings can be serviced separately from the turbocharger.

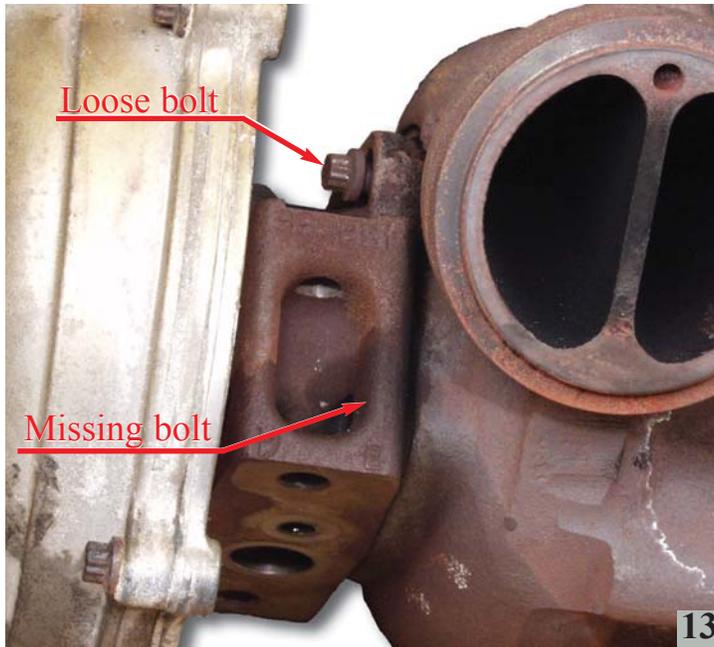
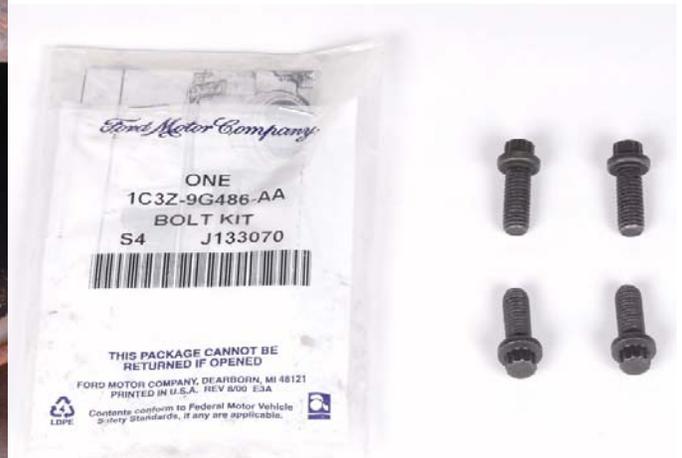
Some turbochargers have experienced turbine housing mounting bolt back out. This does not require turbocharger replacement unless the turbine wheel has contacted the housing and been damaged. Replacement bolts with an interference thread for improved retention are available for service. TSB 03-14-09 advises that the part number for the bolt kit is 1C3Z-9G486-AA. Do not try to "chase" the threads on these bolts.

When loose or missing bolts are found, replace the bolts with part number 1C3Z-9G486-AA per TSB 03-14-09.

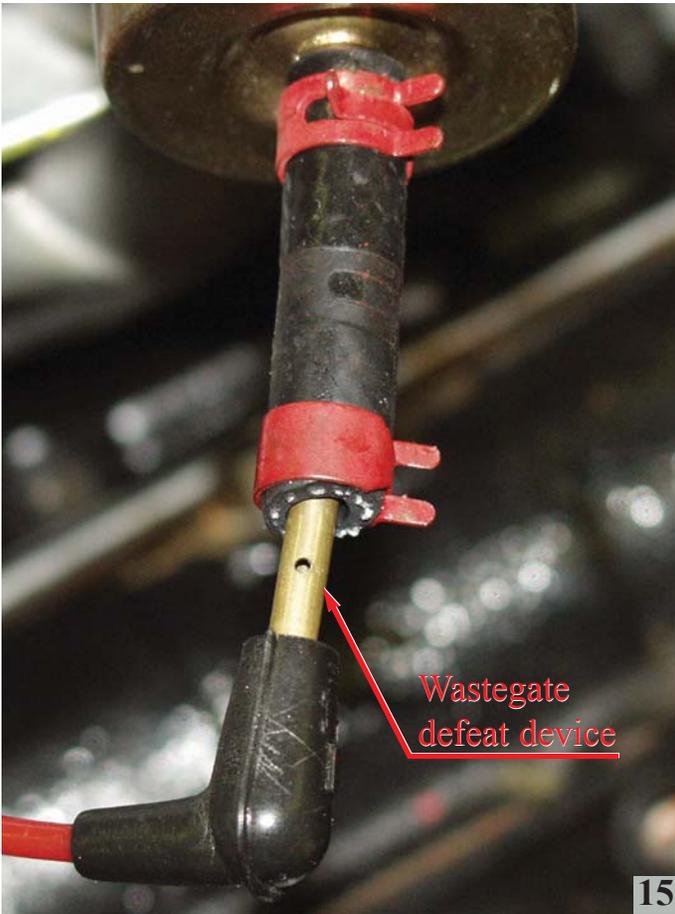
15

**Aftermarket Performance Enhancers:** Above left is a wastegate actuator defeat device which will not allow the wastegate to operate correctly.

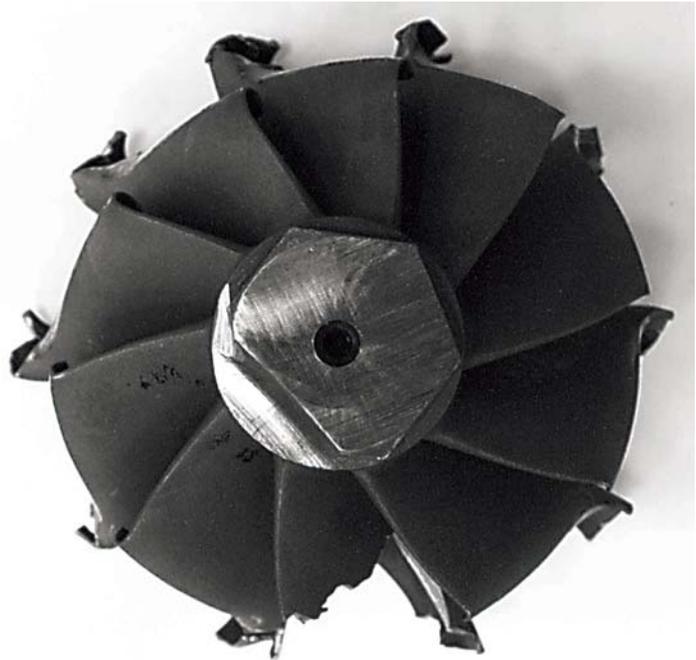
16

**Structural Failure:** Above right is a turbine wheel that has failed due to overspeed as a result of performance modifications.
