Technician Turbocharger Guide for the 6.0L *Power Stroke* Engine

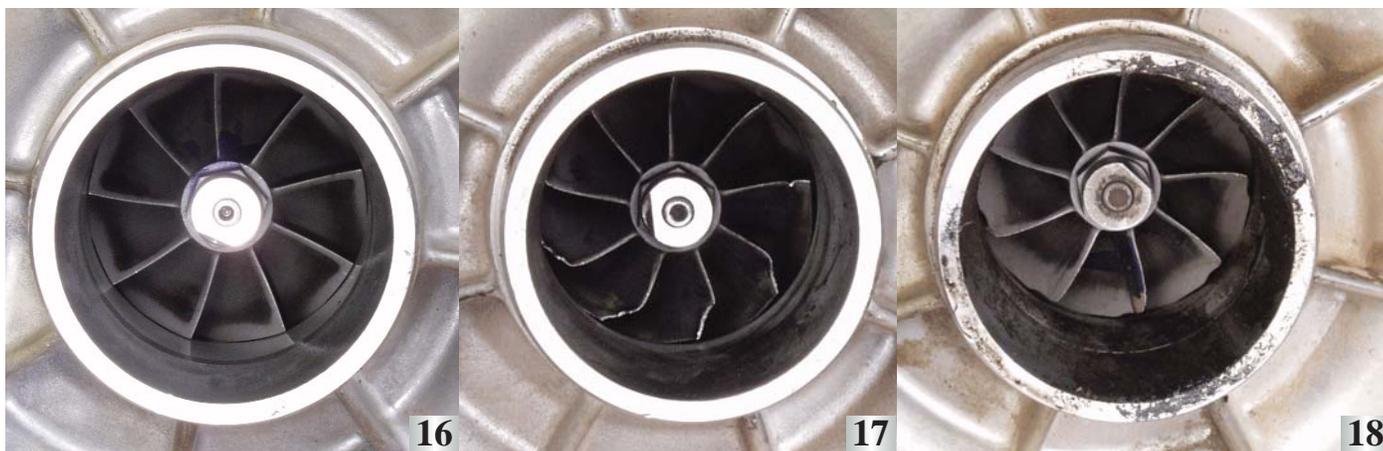
BLADE DAMAGE

Good Turbocharger:

Compressor blades are clean and straight. There are no large gaps between the compressor housing and the compressor wheel. No visible damage to blades. This turbocharger should not be replaced.

Foreign Object Damage:

This compressor wheel shows signs of some outside object (nuts, bolts, screws, etc.) coming in contact with the blades while they were spinning.

Dirt Ingestion:

Also called dusting. The compressor wheel blades show signs of erosion from dirt entering the intake air system. The blades are rounded off and there is dirt accumulation in the compressor inlet.

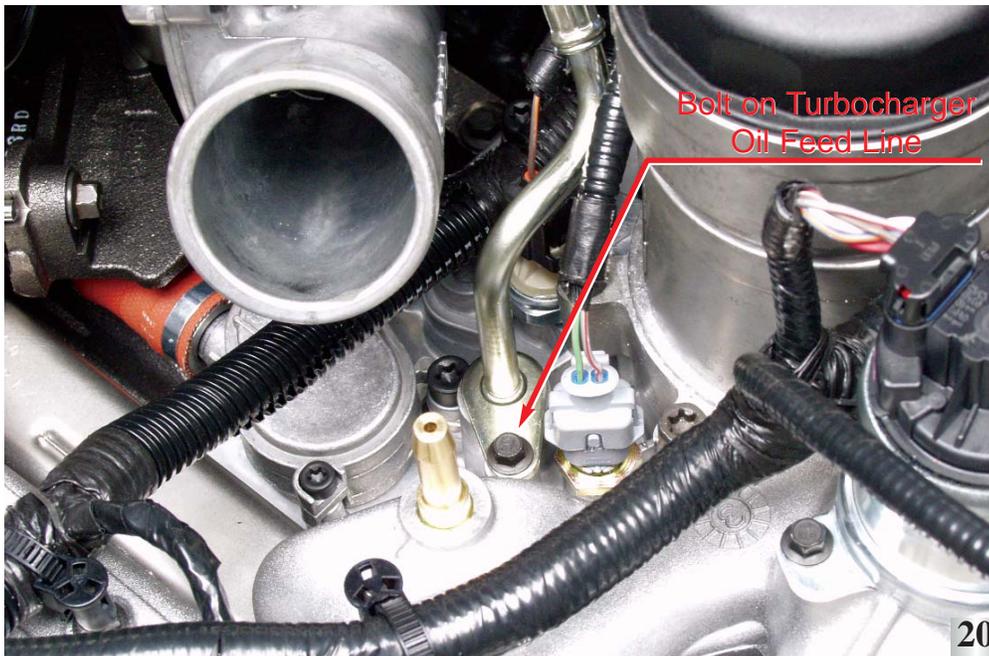
When diagnosing any oil leak it is best to start at the top and most forward point of the affected area. An oil leak that looks like it is coming from the center section may be coming from the oil feed line.

The snap-to-connect turbocharger oil feed line has been replaced with an o-ring sealed, bolt-on line. This was done to reduce leaks due to improper installation.
