2005 6.0L DIT RUNNING CHANGES

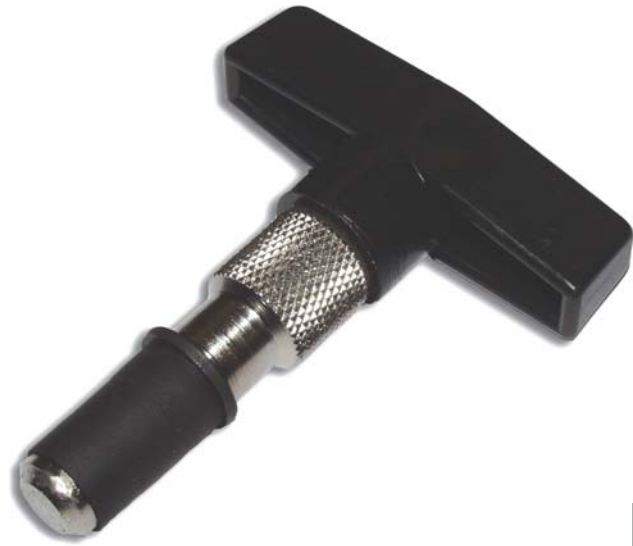
Stand Pipe Removal Tool

- This tool is used to remove the stand pipe from the branch tube if it separates from the high-pressure check valve during disassembly.
- Tool part number 303-1164.

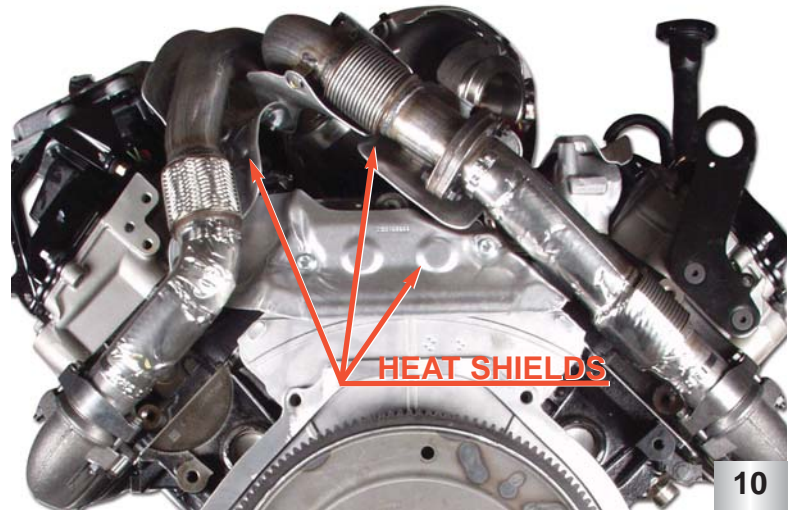
Early Style Rear Heat Shield

- The 2003, 2004, and early production 2005 MY engines have three heat shields in the rear of the engine.
- Two of the shields attach to the exhaust up pipes and the remaining shield attaches to the high-pressure pump cover and left hand cylinder head.

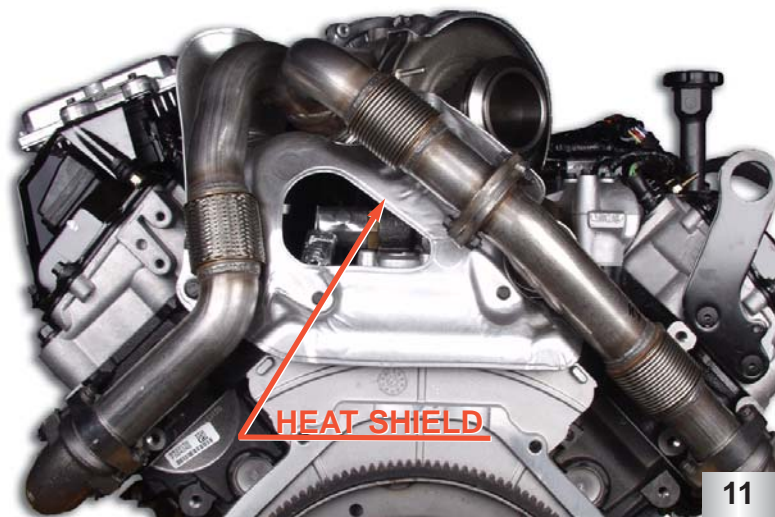
Current Style Rear Heat Shield

- The three heat shields on the 2003, 2004, and early 2005 MY engines have now been incorporated into one large heat shield.
- The new heat shield attaches to the high-pressure pump cover, left hand cylinder head and to the intake manifold.

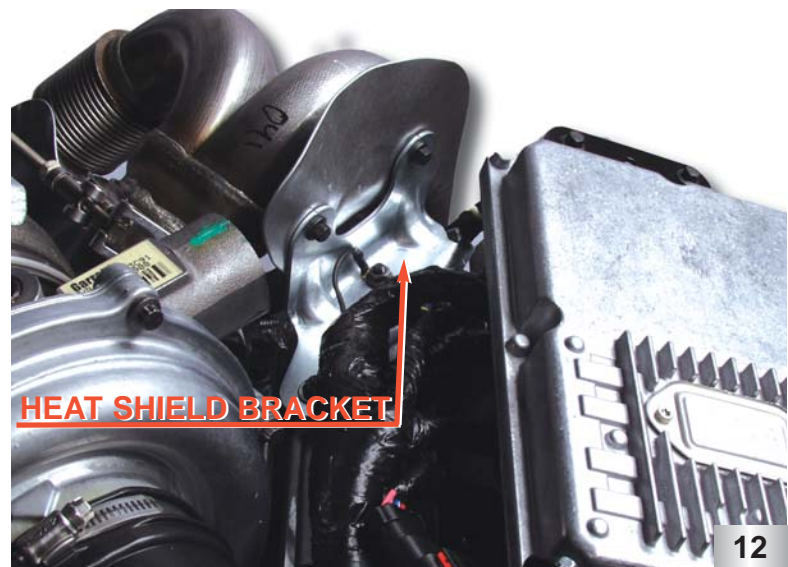
Heat Shield Mounting Bracket

- The new rear heat shield mounting bracket will have to be removed to gain access to the IPR valve.
